**Drainage Report
Sky View Ridge
PFN: M2015-**

**Prepared by:
Joseph M. Smeby, P.E.**

**Job No: 15-02093
May 2015**

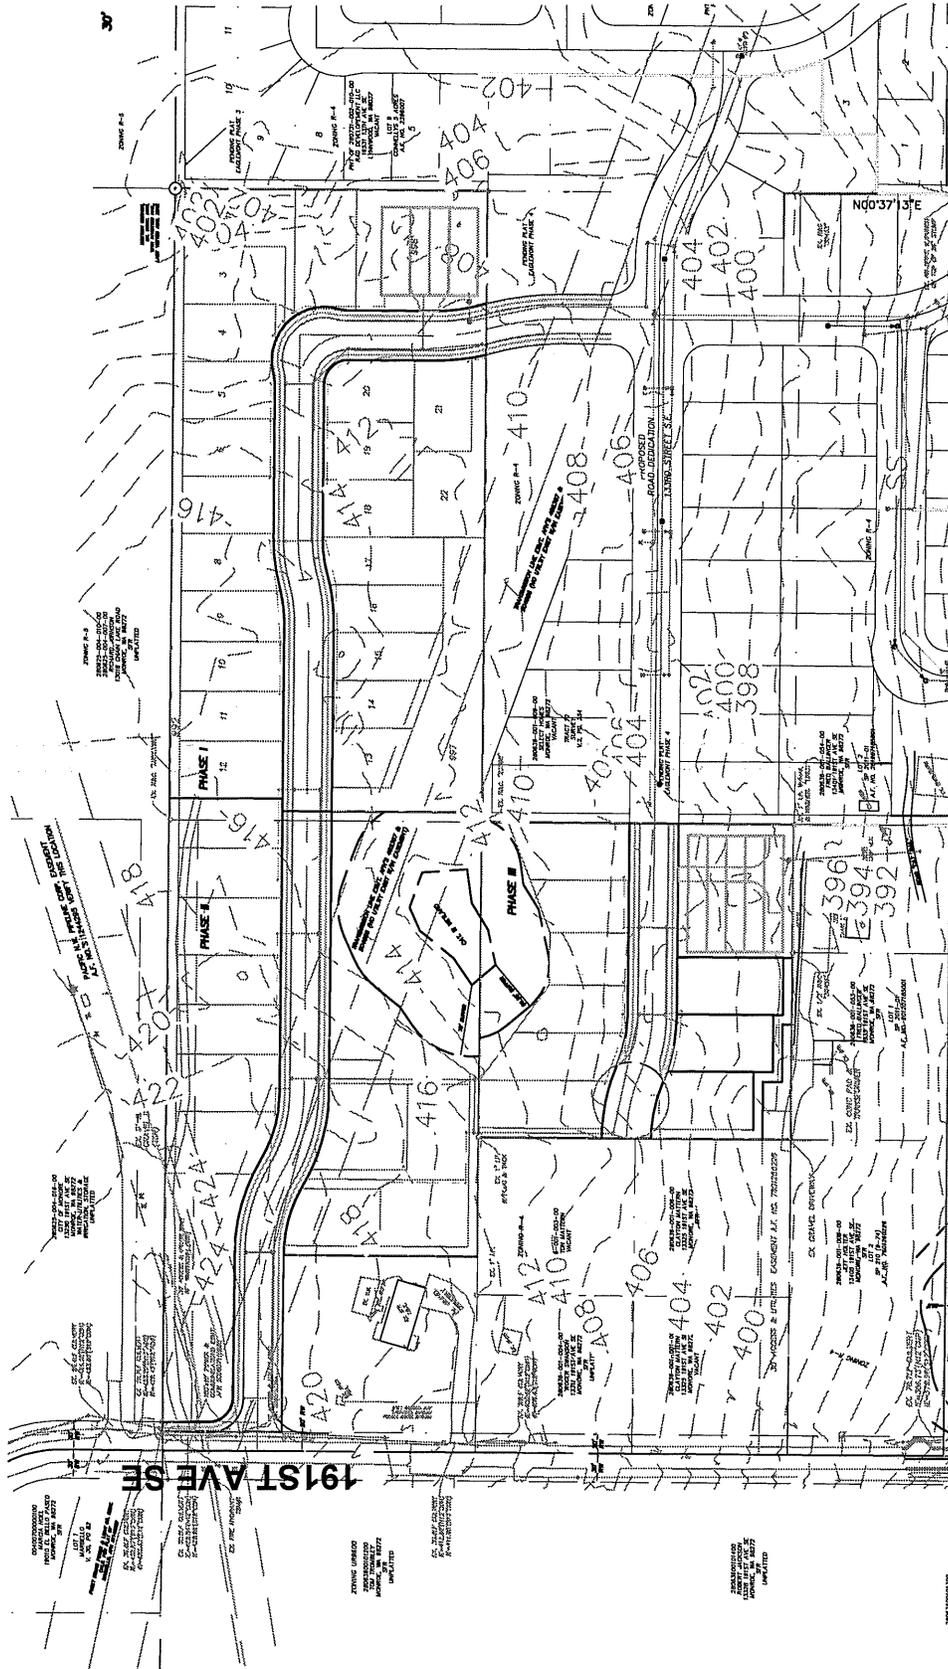
FIG. 2

EXISTING BASIN MAP
 SKY VIEW RIDGE

<u>ITEM</u>		<u>PAGE</u>
FIGURE 1	VICINITY MAP	15
FIGURE 2	EXISTING DRAINAGE BASIN MAP	16
FIGURE 3	DEVELOPED DRAINAGE BASIN MAP	17
FIGURE 4	SNOHOMISH COUNTY SOILS MAP.....	19
FIGURE 5	UPSTREAM/DOWNSTREAM TRIBUTARY AREA MAP.....	20

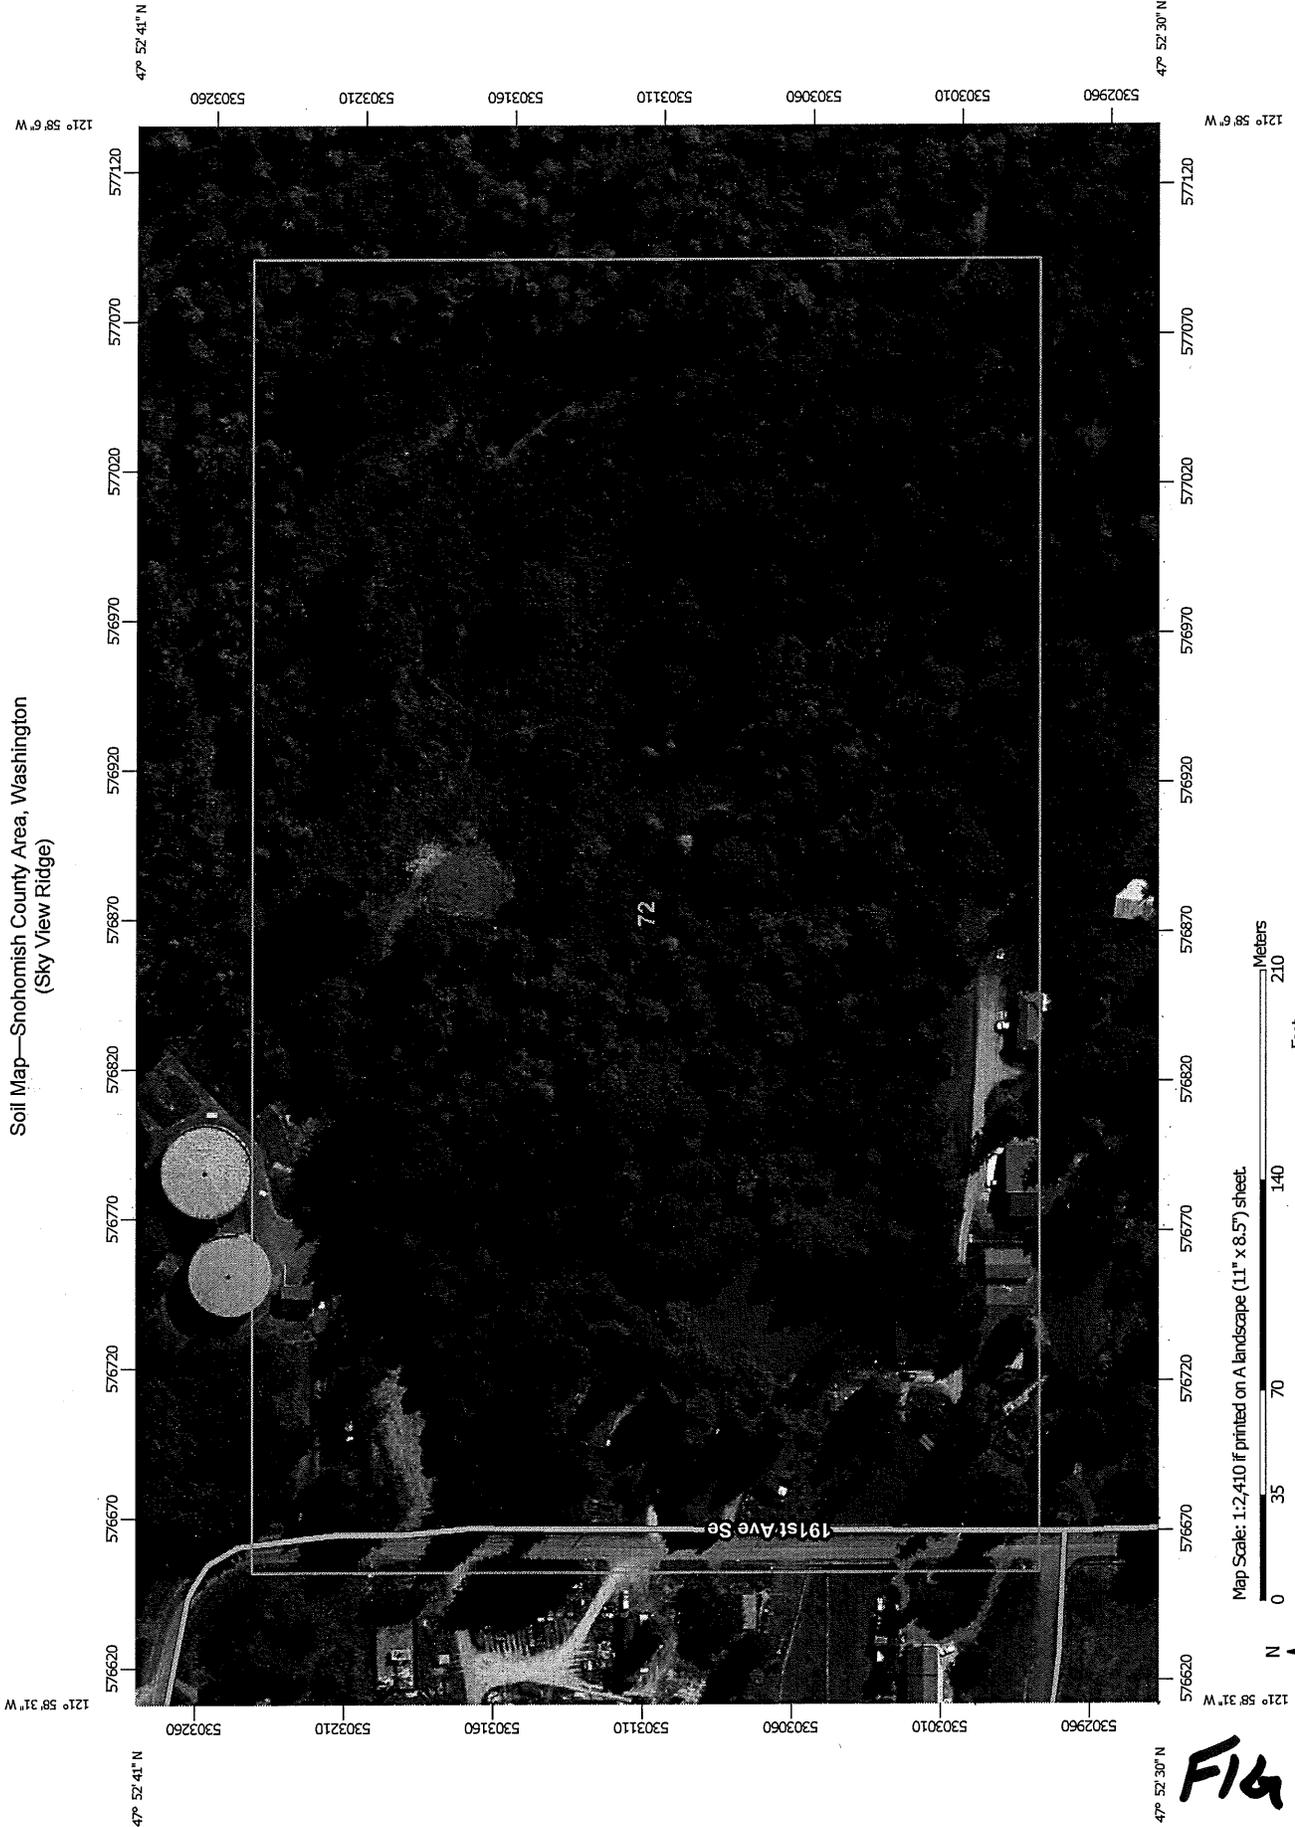
Soil Map—Snohomish County Area, Washington
(Sky View Ridge)

Map Scale: 1:2,410 if printed on A landscape (11" x 8.5") sheet.

The soil hydrologic types for this site have been identified as Type C or Till from the Snohomish County Soil Survey Map, see figure 5. The soil type mapped for this site is Ragnar fine sandy loam. Soil tests on this site found weathered till under 10-18" of topsoil. With hardpan at 1.8-2.5'. Refer to Geotechnical Report in Appendix C. The project Geotech therefore has not recommended that infiltration be used for this project.
