GEOTECHNICAL REPORT

**Garibaldi Property
13424 and 13624 Chain Lake Road
Monroe, Washington**

Project No. T-8079

Terra Associates, Inc.

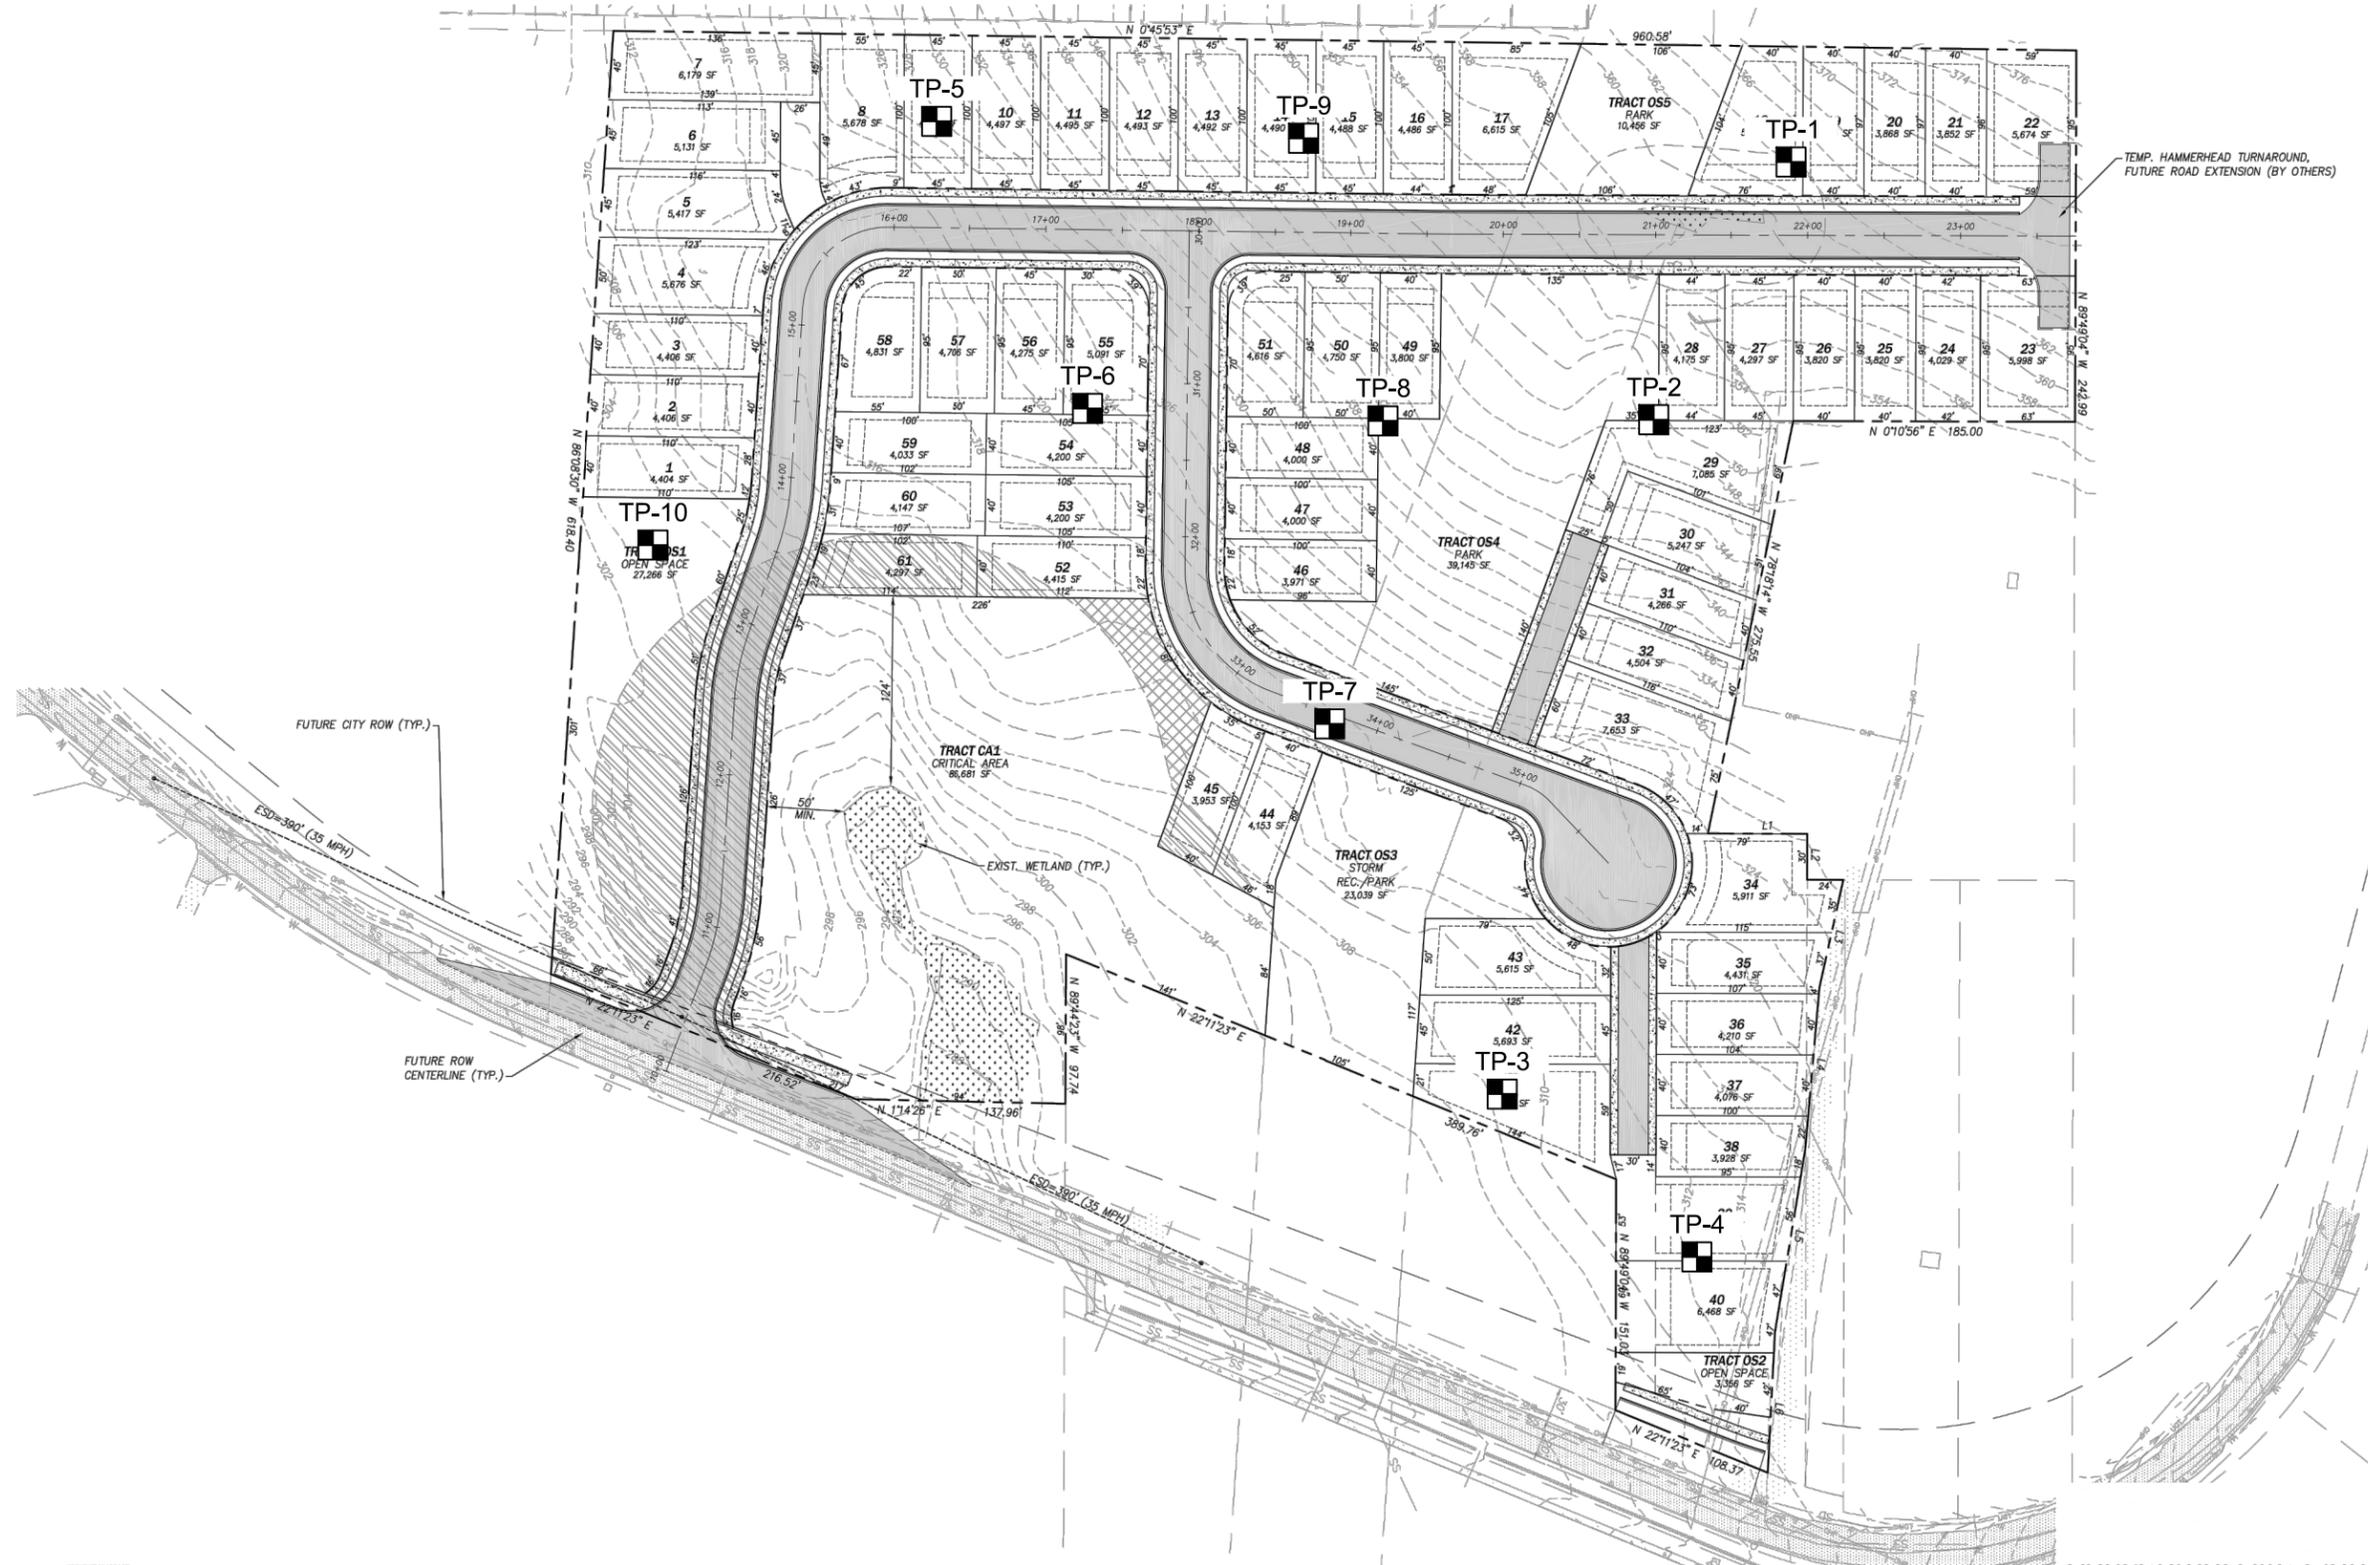
NOTE:

THIS SITE PLAN IS SCHEMATIC. ALL LOCATIONS AND DIMENSIONS ARE APPROXIMATE. IT IS INTENDED FOR REFERENCE ONLY AND SHOULD NOT BE USED FOR DESIGN OR CONSTRUCTION PURPOSES.

Detailed descriptions of the subsurface conditions we observed in the test pits are presented on the Test Pit Logs in Appendix A. The approximate locations of the test pits are shown on Figure 2.
