Preliminary Storm Drainage Report

Belmont Heights PRD

CPH Project No. 0035-18-027

Monroe, WA

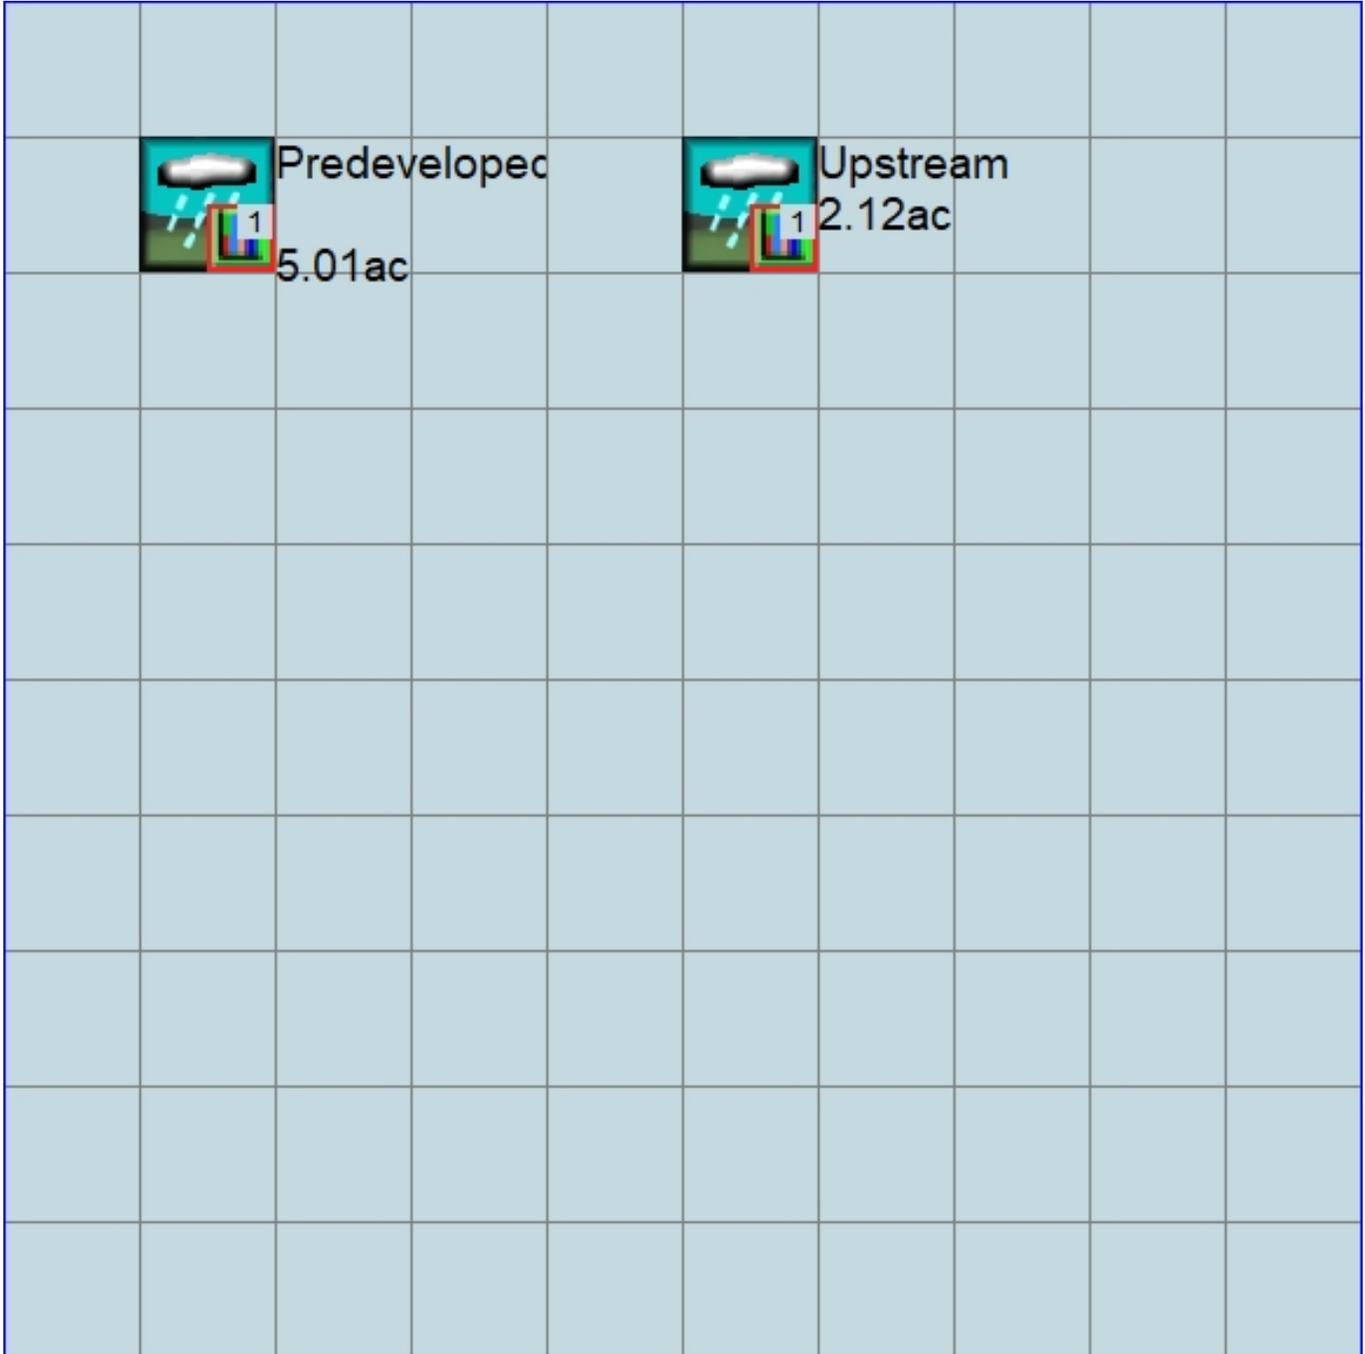
Appendix
Predeveloped Schematic

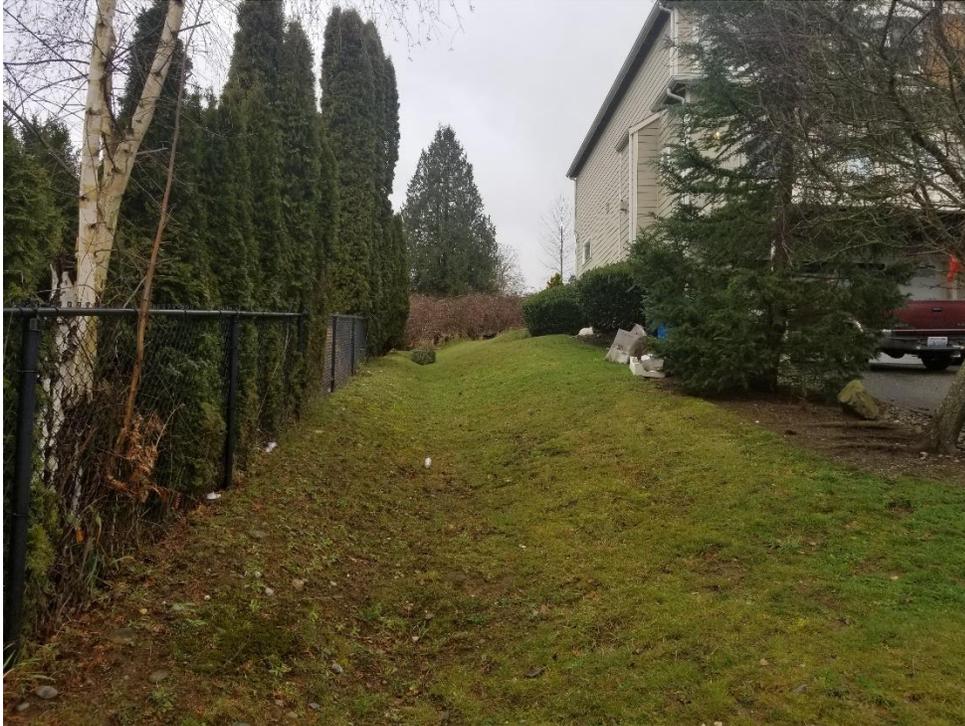
Photo #7: Looking north towards southern property boundary of project site. Buried stormwater pipes between existing house and fence convey flows to Trombley Hill detention pond.

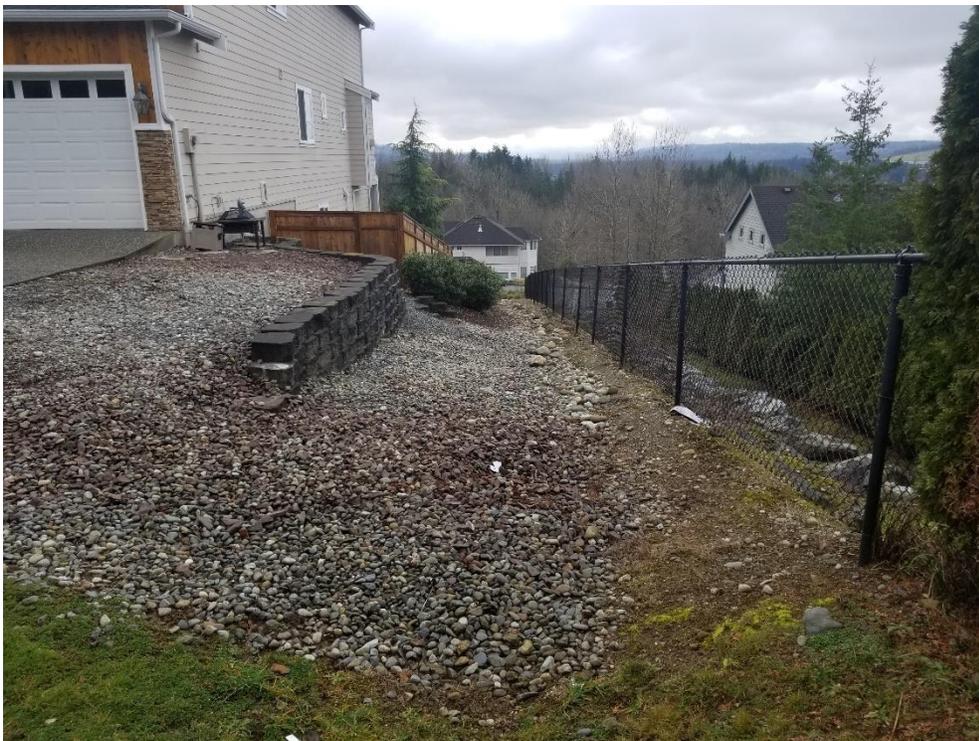
Photo #8: Looking south from same location as photo #7. Buried stormwater pipes between existing house and fence convey flows to Trombley Hill detention pond.

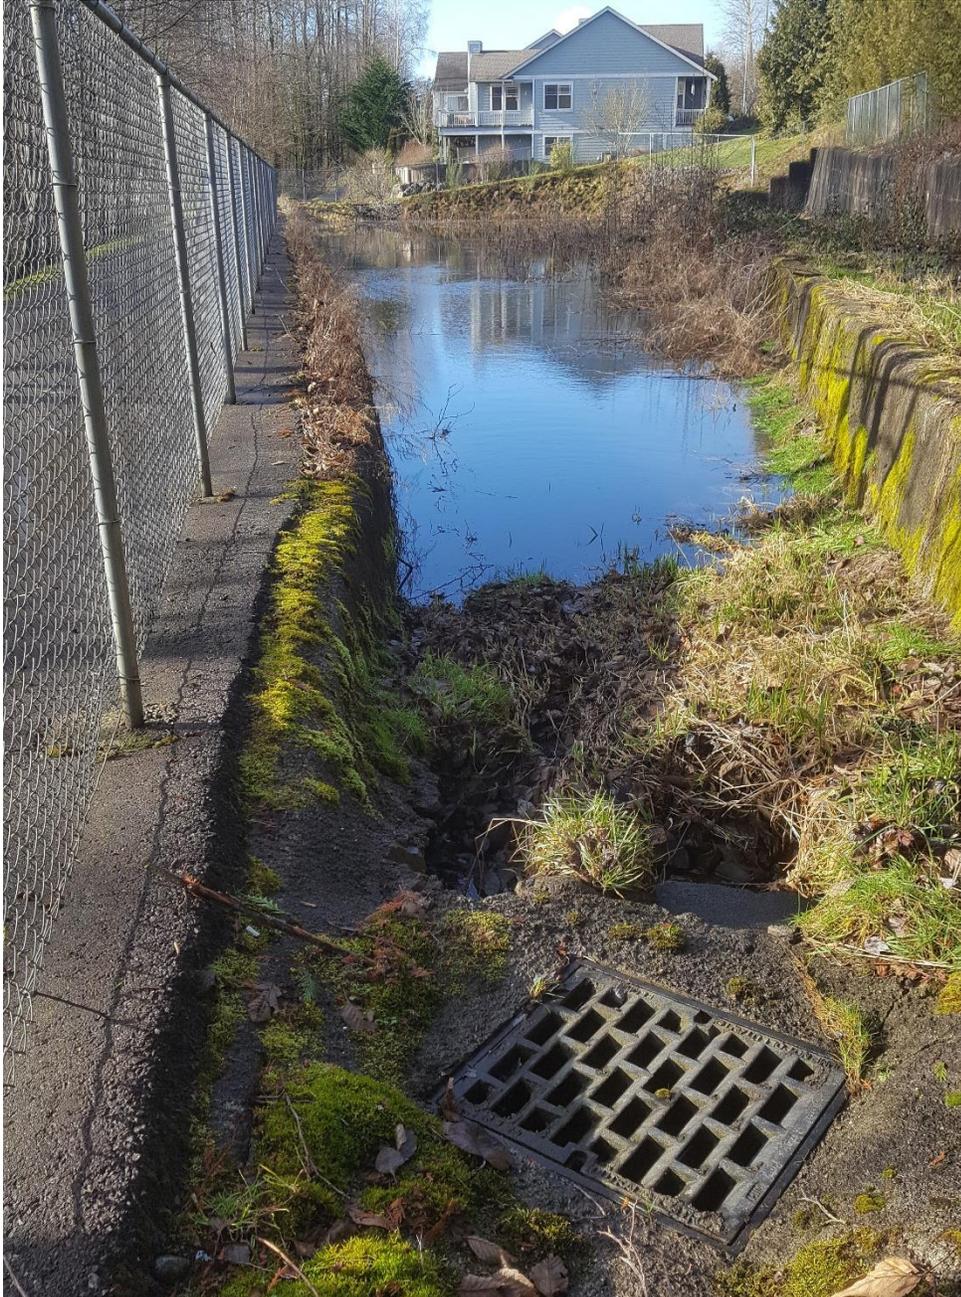
Photo #9: Looking west at Trombley Hill detention pond.

3	Catch basins and conveyance pipes	Runoff flows through a series of catch basins and underground pipes	~12%	5' - 955'	None observed		See downstream map
4	Detention Pond	Runoff discharges into Trombley Hill detention pond	0%	955' – 1200'	None observed		See photo #9
5	Control Structure and conveyance pipes	Runoff discharges from pond and ultimately outfalls to a wetland southwest of pond	~4%	1200' – 1320'	None observed		See downstream map
