**GEOTECHNICAL ENGINEERING STUDY
EAGLEMONT 7 PRD
13202 CHAIN LAKE ROAD AND
13107 - 197TH AVENUE SOUTHEAST
MONROE, WASHINGTON**

ES-3217.12

MAINVUE WA, LLC

**October 3, 2017
Updated July 30, 2018**

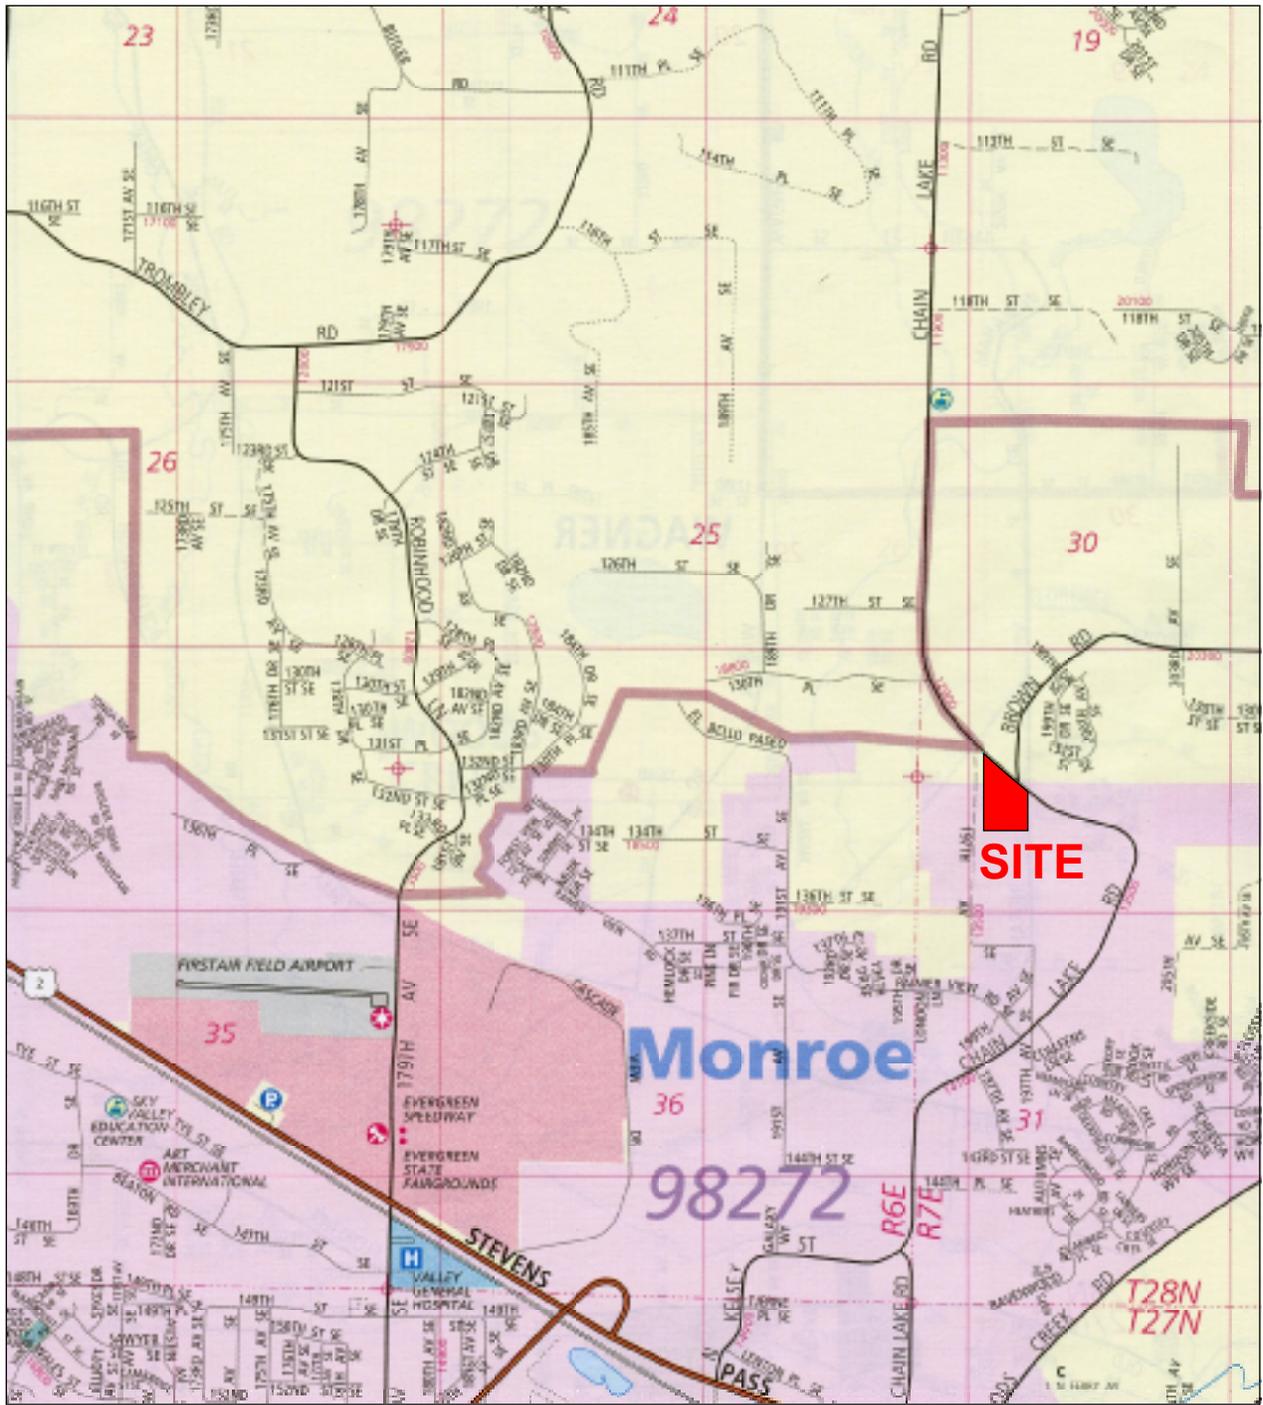
Drwn. MRS	Date 07/23/2018	Proj. No. 3217.12
Checked BST	Date July 2018	Plate 1

Reference:
 Snohomish County, Washington
 Map 438
 By The Thomas Guide
 Rand McNally
 32nd Edition

The subject site is located directly southwest of the Brown Road and Chain Lake Road intersection, near the boundary between unincorporated Snohomish County and the City of Monroe, Washington. The approximate location of the subject site is depicted on Plate 1 (Vicinity Map). The property is comprised of two tax parcels (Snohomish County Parcel Numbers 280731-002-023-00 and 280730-003-013-00) totaling approximately 9 acres. The site is currently developed with a vacant, dilapidated single-family residential home with a detached barn structure in the south-central site area and several mobile homes and outdoor structures in the northern site area. The remainder of the site is undeveloped, and vegetation is comprised of trees, shrubs, and grasses.

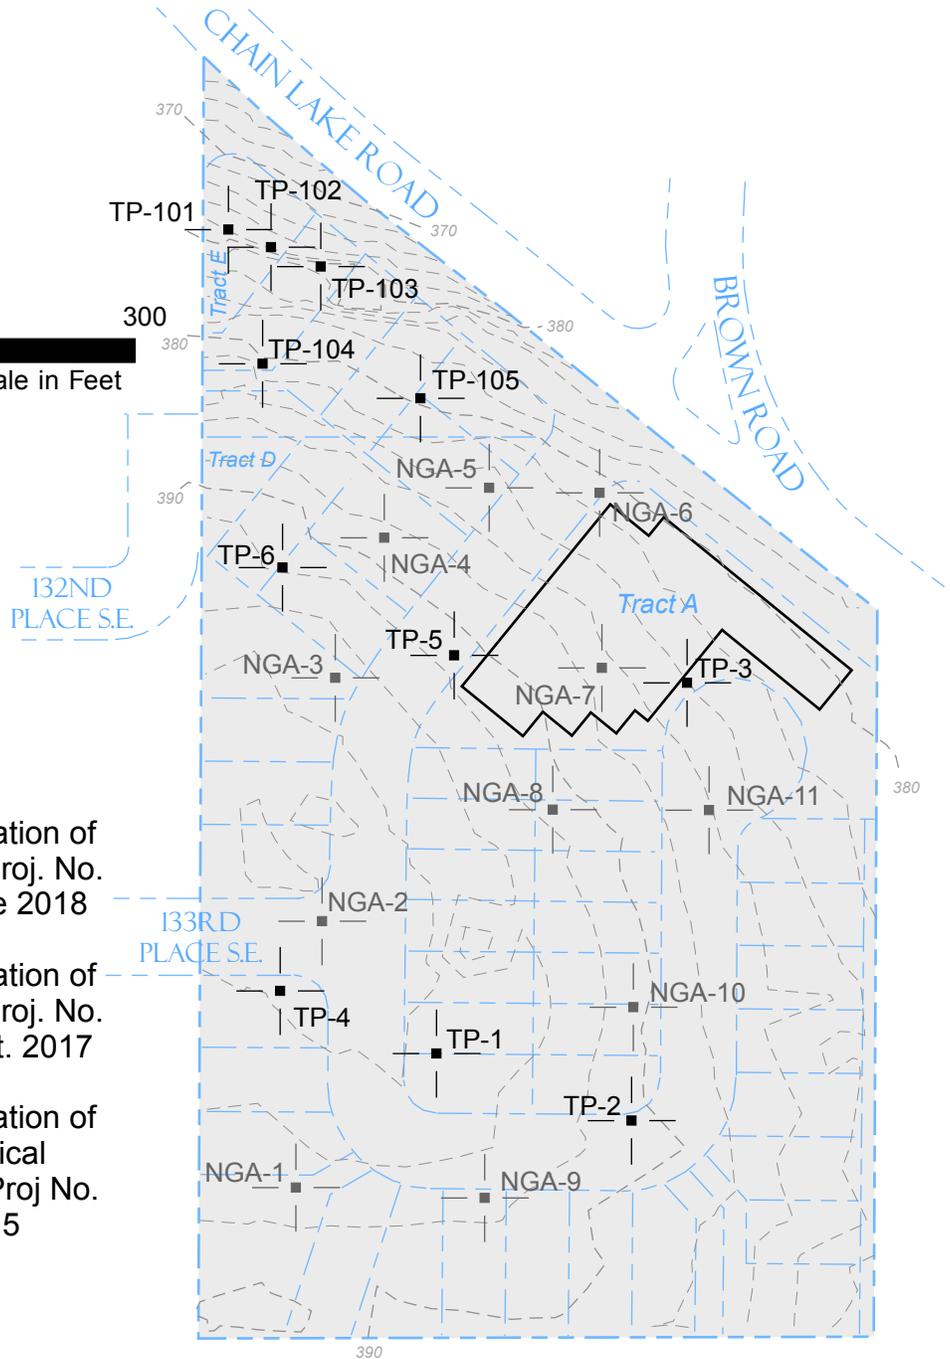
Drwn. MRS	Date 07/24/2018	Proj. No. 3217.12
Checked BST	Date July 2018	Plate 2

- TP-101 | Approximate Location of ESNW Test Pit, Proj. No. ES-3217.12, June 2018
- TP-1 | Approximate Location of ESNW Test Pit, Proj. No. ES-3217.09, Sept. 2017
- NGA-1 | Approximate Location of Nelson Geotechnical Associates, Inc. Proj No. 929415, Aug. 2015
- Subject Site
- Existing Building

Test Pit Location Plan
Eaglemont 7 PRD
Monroe, Washington

For clarity, all further references to subsurface soil and groundwater conditions will relate to the information collected during the ESNW subsurface explorations completed in September 2017 and June 2018. Although depicted on Plate 2 and included with the attached test pits logs, information collected by Nelson Geotechnical Associates, Inc. in August 2015 will not be referenced.

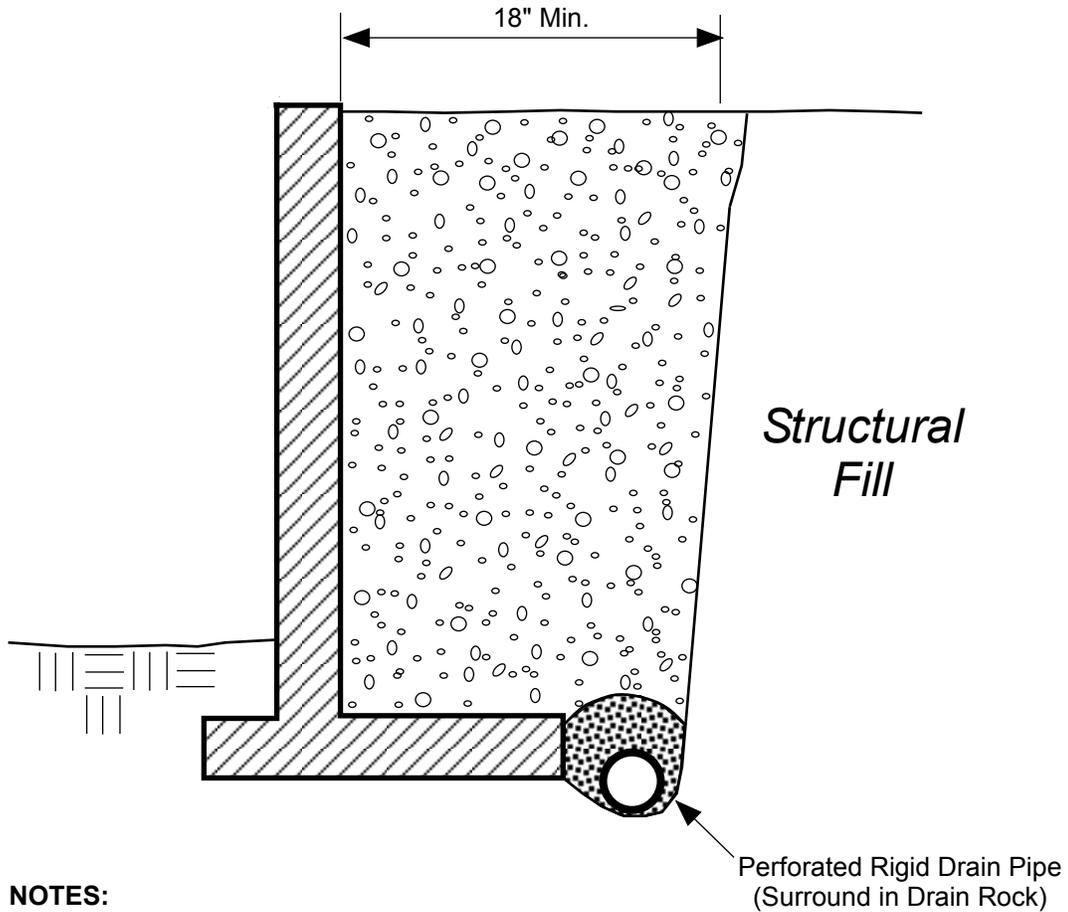
Earth Solutions NW_{LLC} Geotechnical Engineering Construction Observation/Testing and Environmental Services
Retaining Wall Drainage Detail Egglemont 7 PRD Monroe, Washington		
Drwn. MRS	Date 07/23/2018	Proj. No. 3217.12
Checked BST	Date July 2018	Plate 3

- Free-draining Backfill should consist of soil having less than 5 percent fines. Percent passing No. 4 sieve should be 25 to 75 percent.
- Sheet Drain may be feasible in lieu of Free-draining Backfill, per ESNW recommendations.
- Drain Pipe should consist of perforated, rigid PVC Pipe surrounded with 1-inch Drain Rock.

Retaining walls should be backfilled with free-draining material that extends along the height of the wall and a distance of at least 18 inches behind the wall. The upper 12 inches of the wall backfill may consist of a less permeable soil, if desired. A perforated drainpipe should be placed along the base of the wall and connected to an approved discharge location. A typical retaining wall drainage detail is provided on Plate 3. If drainage is not provided, hydrostatic pressures should be included in the wall design.

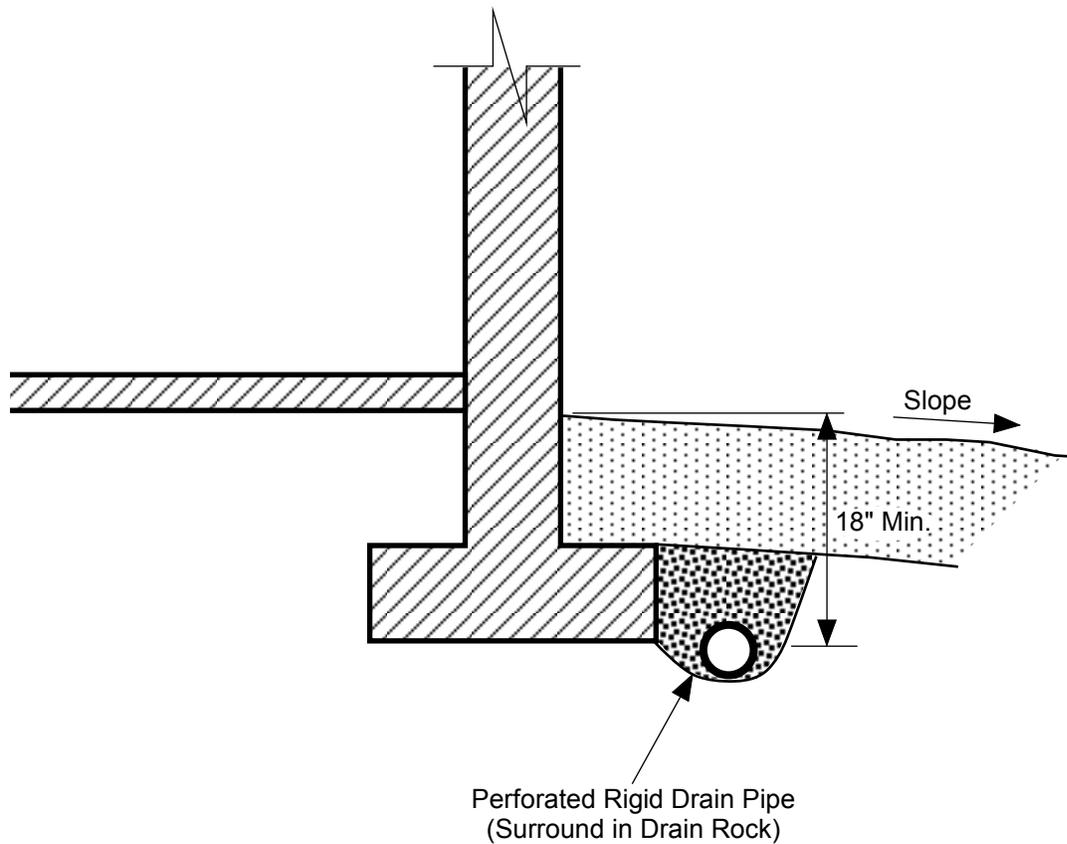
- Do NOT tie roof downspouts to Footing Drain.
- Surface Seal to consist of 12" of less permeable, suitable soil. Slope away from building.

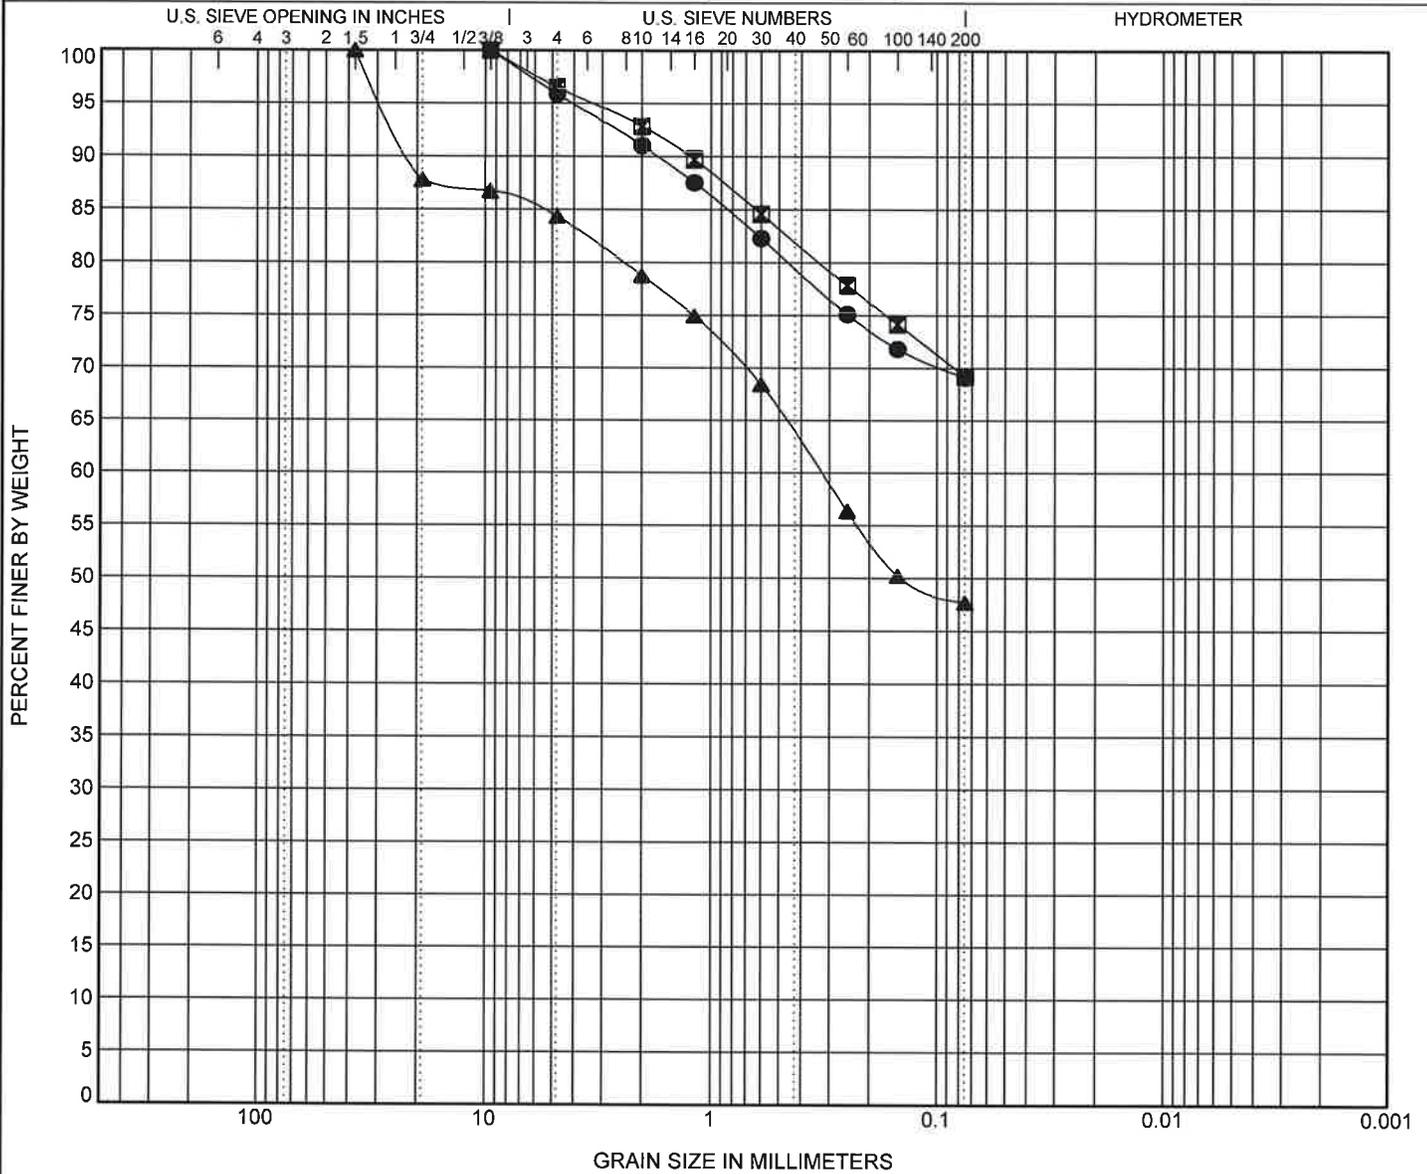
COBBLES	GRAVEL		SAND			SILT OR CLAY
	coarse	fine	coarse	medium	fine

Specimen Identification	Classification	Cc	Cu
● TP-101 7.00ft.	USDA: Gray Slightly Gravelly Loam. USCS: ML.		
■ TP-104 4.00ft.	USDA: Brown Slightly Gravelly Loam. USCS: ML.		
▲ TP-105 5.00ft.	USDA: Gray Gravelly Loam. USCS: SM with Gravel.
